Typical brake disc and brake pad damage patterns and their root causes

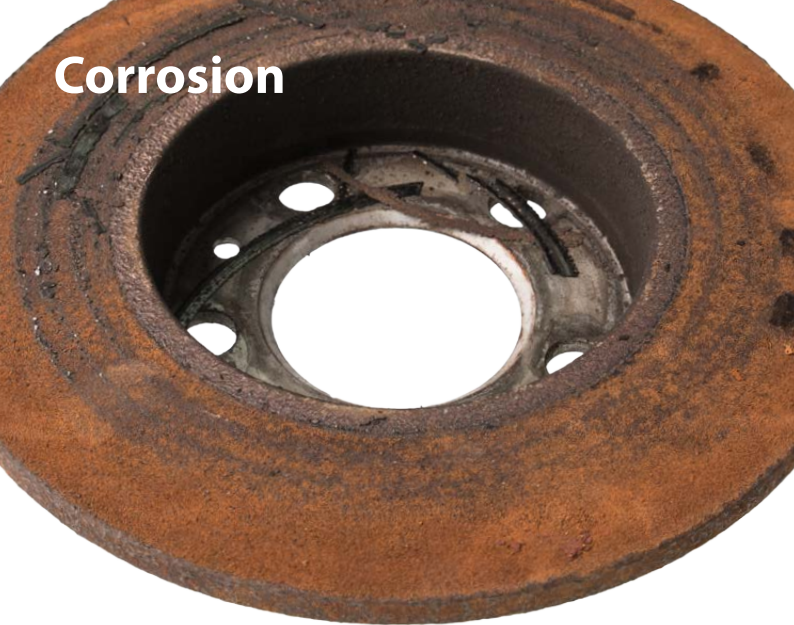
Corrosion

The problem:

Severe rust formation on brake discs and pads.

Causes:

- › Climatic effects (e.g. road salt, moisture)
- › Extended periods of downtime with parking brake engaged
- › Brake piston stuck in calliper
- › Brake piston not fully returned to retracted position

Possible consequences:

- › Vibration and brake judder caused by brake disc deposits
- › Noise generation
- › Reduced braking power
- › Overheating of brake discs and pads caused by rust spots

MEYLE's *advice*:

Avoid extended periods of vehicle downtime with parking brake continually engaged. Ensure all components are free-moving. After extended periods of downtime cautiously apply the brakes to unlock the brake system and ensure rust spots have been removed.

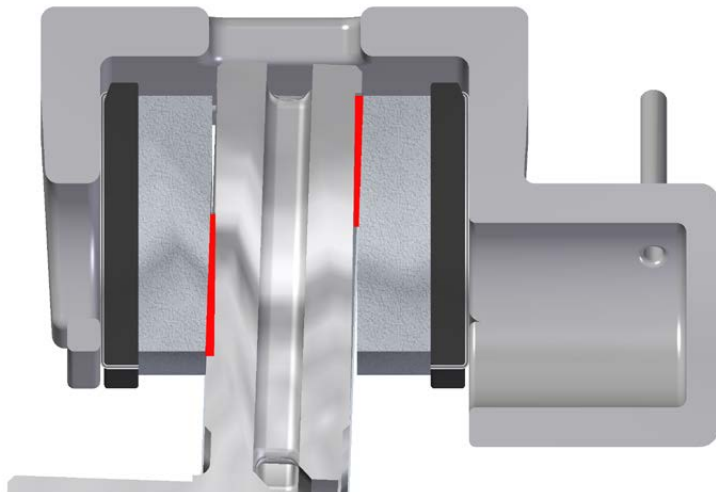
Wheel hub run-out

The problem:

Asymmetrical wear of brake disc front and rear sides. Formation of bluish-black hotspots.

Causes:

- › Brake disc fails to fit flush against wheel hub
- › Misalignment of functional axes
- › Wheel hub misalignment in relation to brake calliper

Possible consequences:

- › Pulsing brake pedal/judder
- › Shaking steering wheel
- › Reduced braking power
- › Wear limit reached prematurely

MEYLE's *advice*:

Brake discs must be installed clean, dry and degreased. Check wheel hub for true running prior to brake disc installation.

NOTE: Any existing wheel hub run-out is doubled owing to the larger brake disc diameter. Using a dial gauge with adjustable magnetic base allows you to check for installation-induced run-out directly on the car instead of performing a test drive.

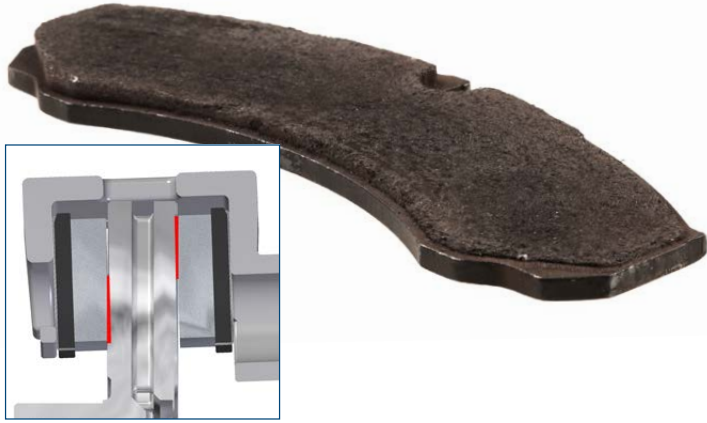
The problem:

Brake pad is pressed unevenly against brake disc.

Causes:

- › Brake pad seized
- › Problems during installing
- › Anti-squeal shims out of place
- › Brake calliper positioned incorrectly

Possible consequences:

- › Asymmetrical wear of brake disc front and rear sides
- › Reduced braking power
- › Pulsing brake pedal/judder
- › Shaking steering wheel
- › Possible noise generation
- › Wear limit reached prematurely

MEYLE's *advice*:

Ensure all components are free-moving. Ensure correct positioning of brake calliper. Observe mounting instructions.

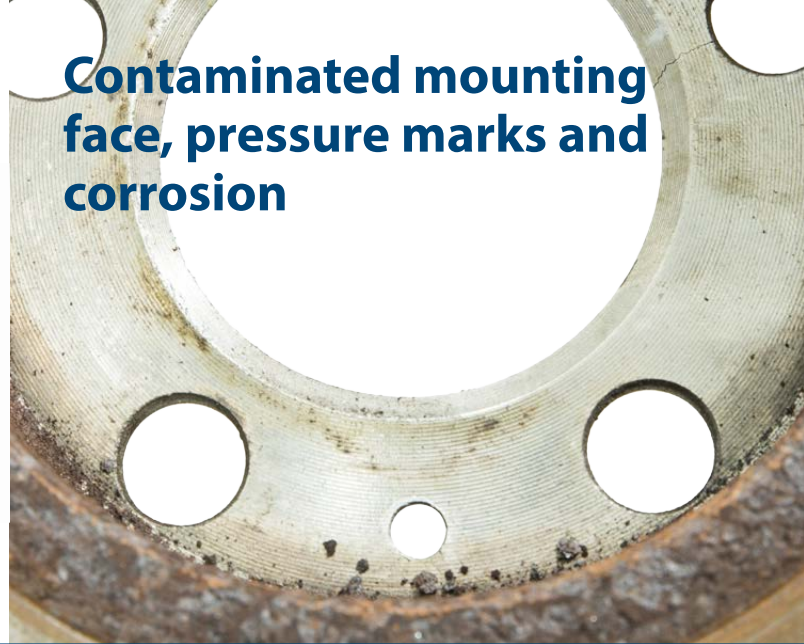
Contaminated mounting face, pressure marks and corrosion

The problem:

Plane-parallel installation is not or not fully possible.

Causes:

- › Failure to clean wheel hub mounting face correctly
- › Dirt or rust particles trapped between brake disc and hub
- › Grease/paste from foreign objects trapped between brake disc and wheel hub

Possible consequences:

- › Asymmetrical wear
- › Pulsing brake pedal/judder
- › Shaking steering wheel
- › Reduced braking power
- › Wear limit reached prematurely

MEYLE's *advice*:

Mounting face must be clean, dry and rust-free. Check wheel hub for true running/run-out prior to brake disc installation. Using a dial gauge with adjustable magnetic base allows you to check for installation-induced run-out directly on the car instead of performing a test drive.

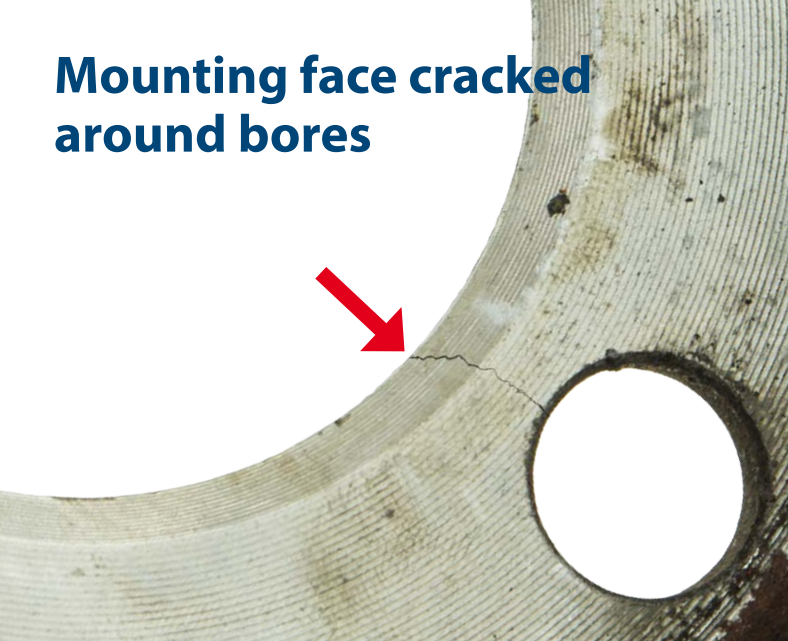
Mounting face cracked around bores

The problem:

Formation of cracks in area surrounding wheel bolt holes.

Causes:

- › Excessive torque to tighten wheel nuts and bolts
- › Failure to tighten wheel nuts and bolts in correct order
- › Lack of plane-parallel alignment between wheel hub and brake disc

Possible consequences:

- › Brake disc shakes immediately after installation
- › Mounting face deformation (cracks might not be visible)
- › Brake disc cracks under load

MEYLE's advice:

Adhere to tightening torques and sequences specified by the manufacturer. Ensure plane-parallel installation. Using a dial gauge with adjustable magnetic base allows you to check for installation-induced run-out directly on the car instead of performing a test drive.
